MOUNTAIN BROOK DAM

NH 00099
NHWRB 124.17

PHASE I INSPECTION REPORT
NATIONAL DAM INSPECTION PROGRAM

DECEMBER 1979

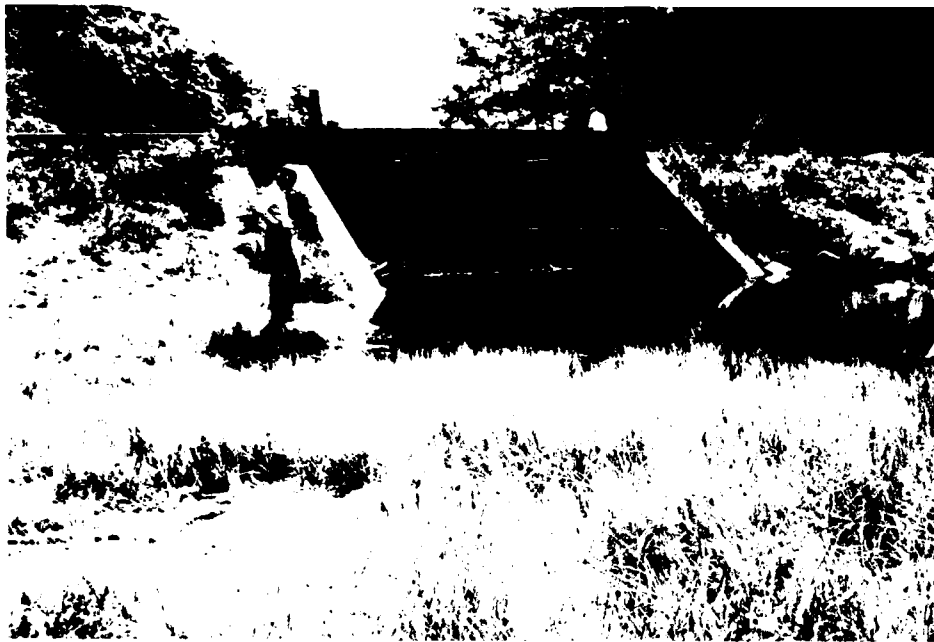
Overview from left upstream side

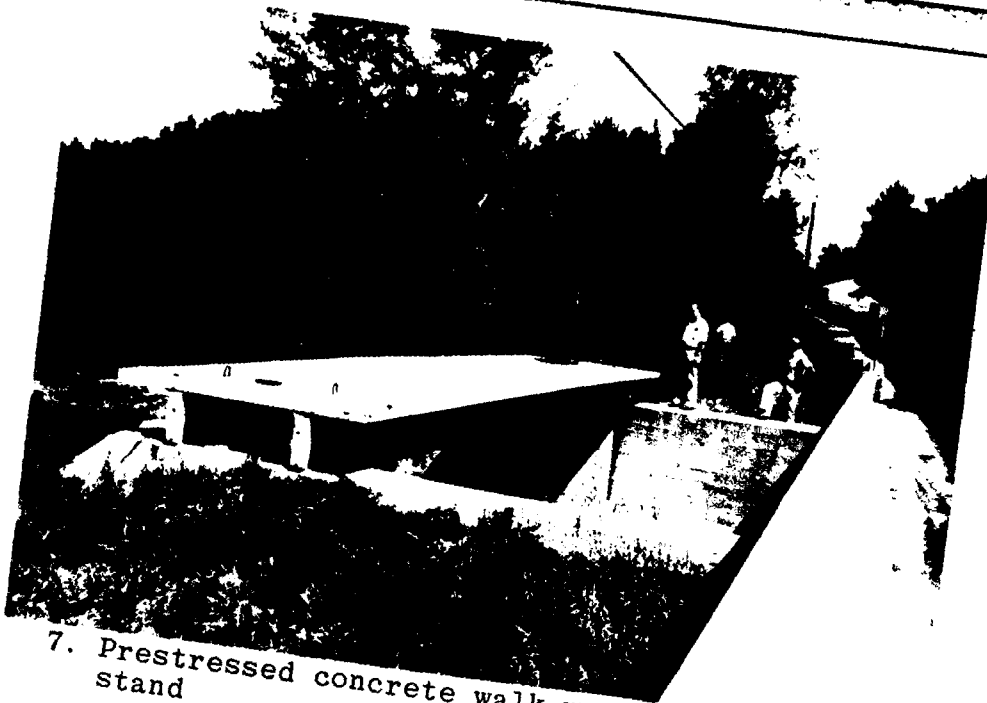
The prestressed concrete walkway is in good condition with the exception of minor surface spalling and minor rusting of the anchorage system. There is no safety rail on this structure.

The gate bench stand shows some surface rusting and has not been greased in the recent past. The pipe stem has also rusted.

7. Prestressed concrete walk way with bench stand

- 2) Grease the sluice gatebench stand, rehabilitate and operate the gate.
- 3) Install safety railing around the concrete walkway.
- 4) Remove trees and saplings, including their roots, from the slopes of the embankment. Backfill the resulting voids with suitable compacted material.
- 5) Remove flashboards and pins.
- 6) Repair spalled and cracked concrete on end walls.
- 7) Implement a program of biennial technical inspections of the dam and its appurtenances including operation of the sluice gate.
- 9) Develop a formal written downstream emergency warning system.

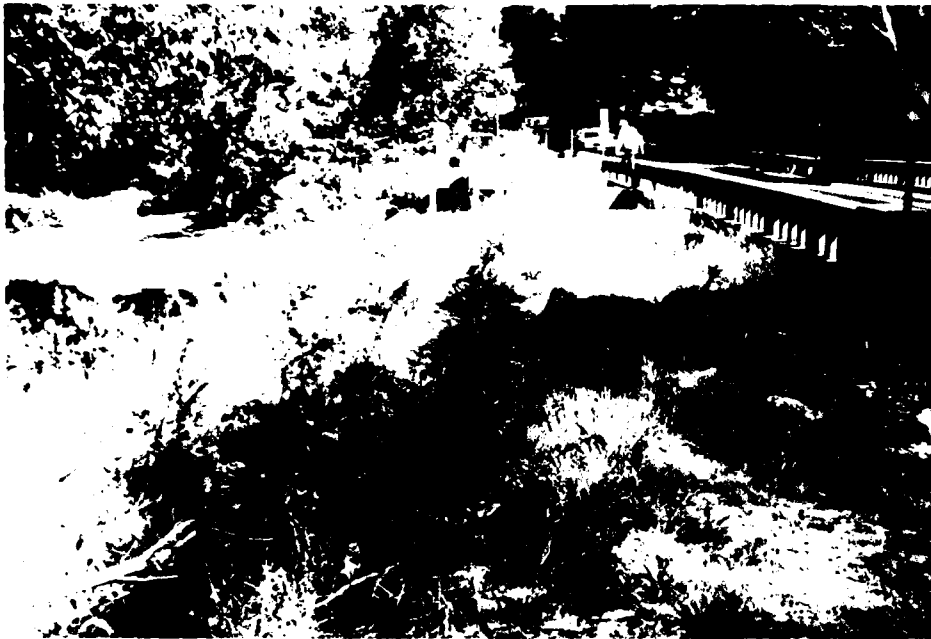
5. Crest of dam showing core wall, walk way, and highway bridge

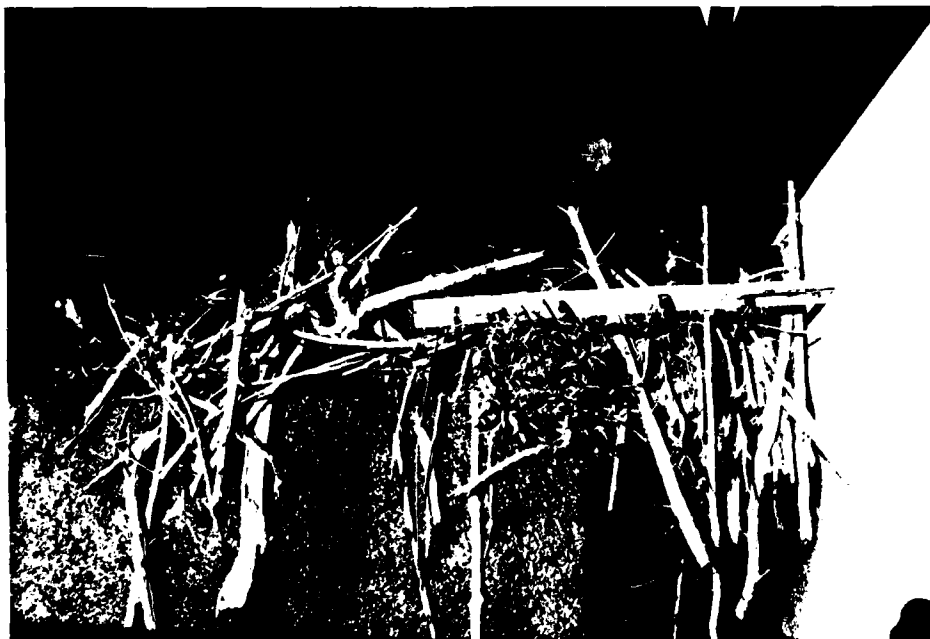
10. Crest of spillway showing remains of
pin boards and debris
